# **Terrain Hazard Assessment and Construction Inspection Report**

## **May and Jennie Project**

### **Fortynine Creek**

July 5, 2018

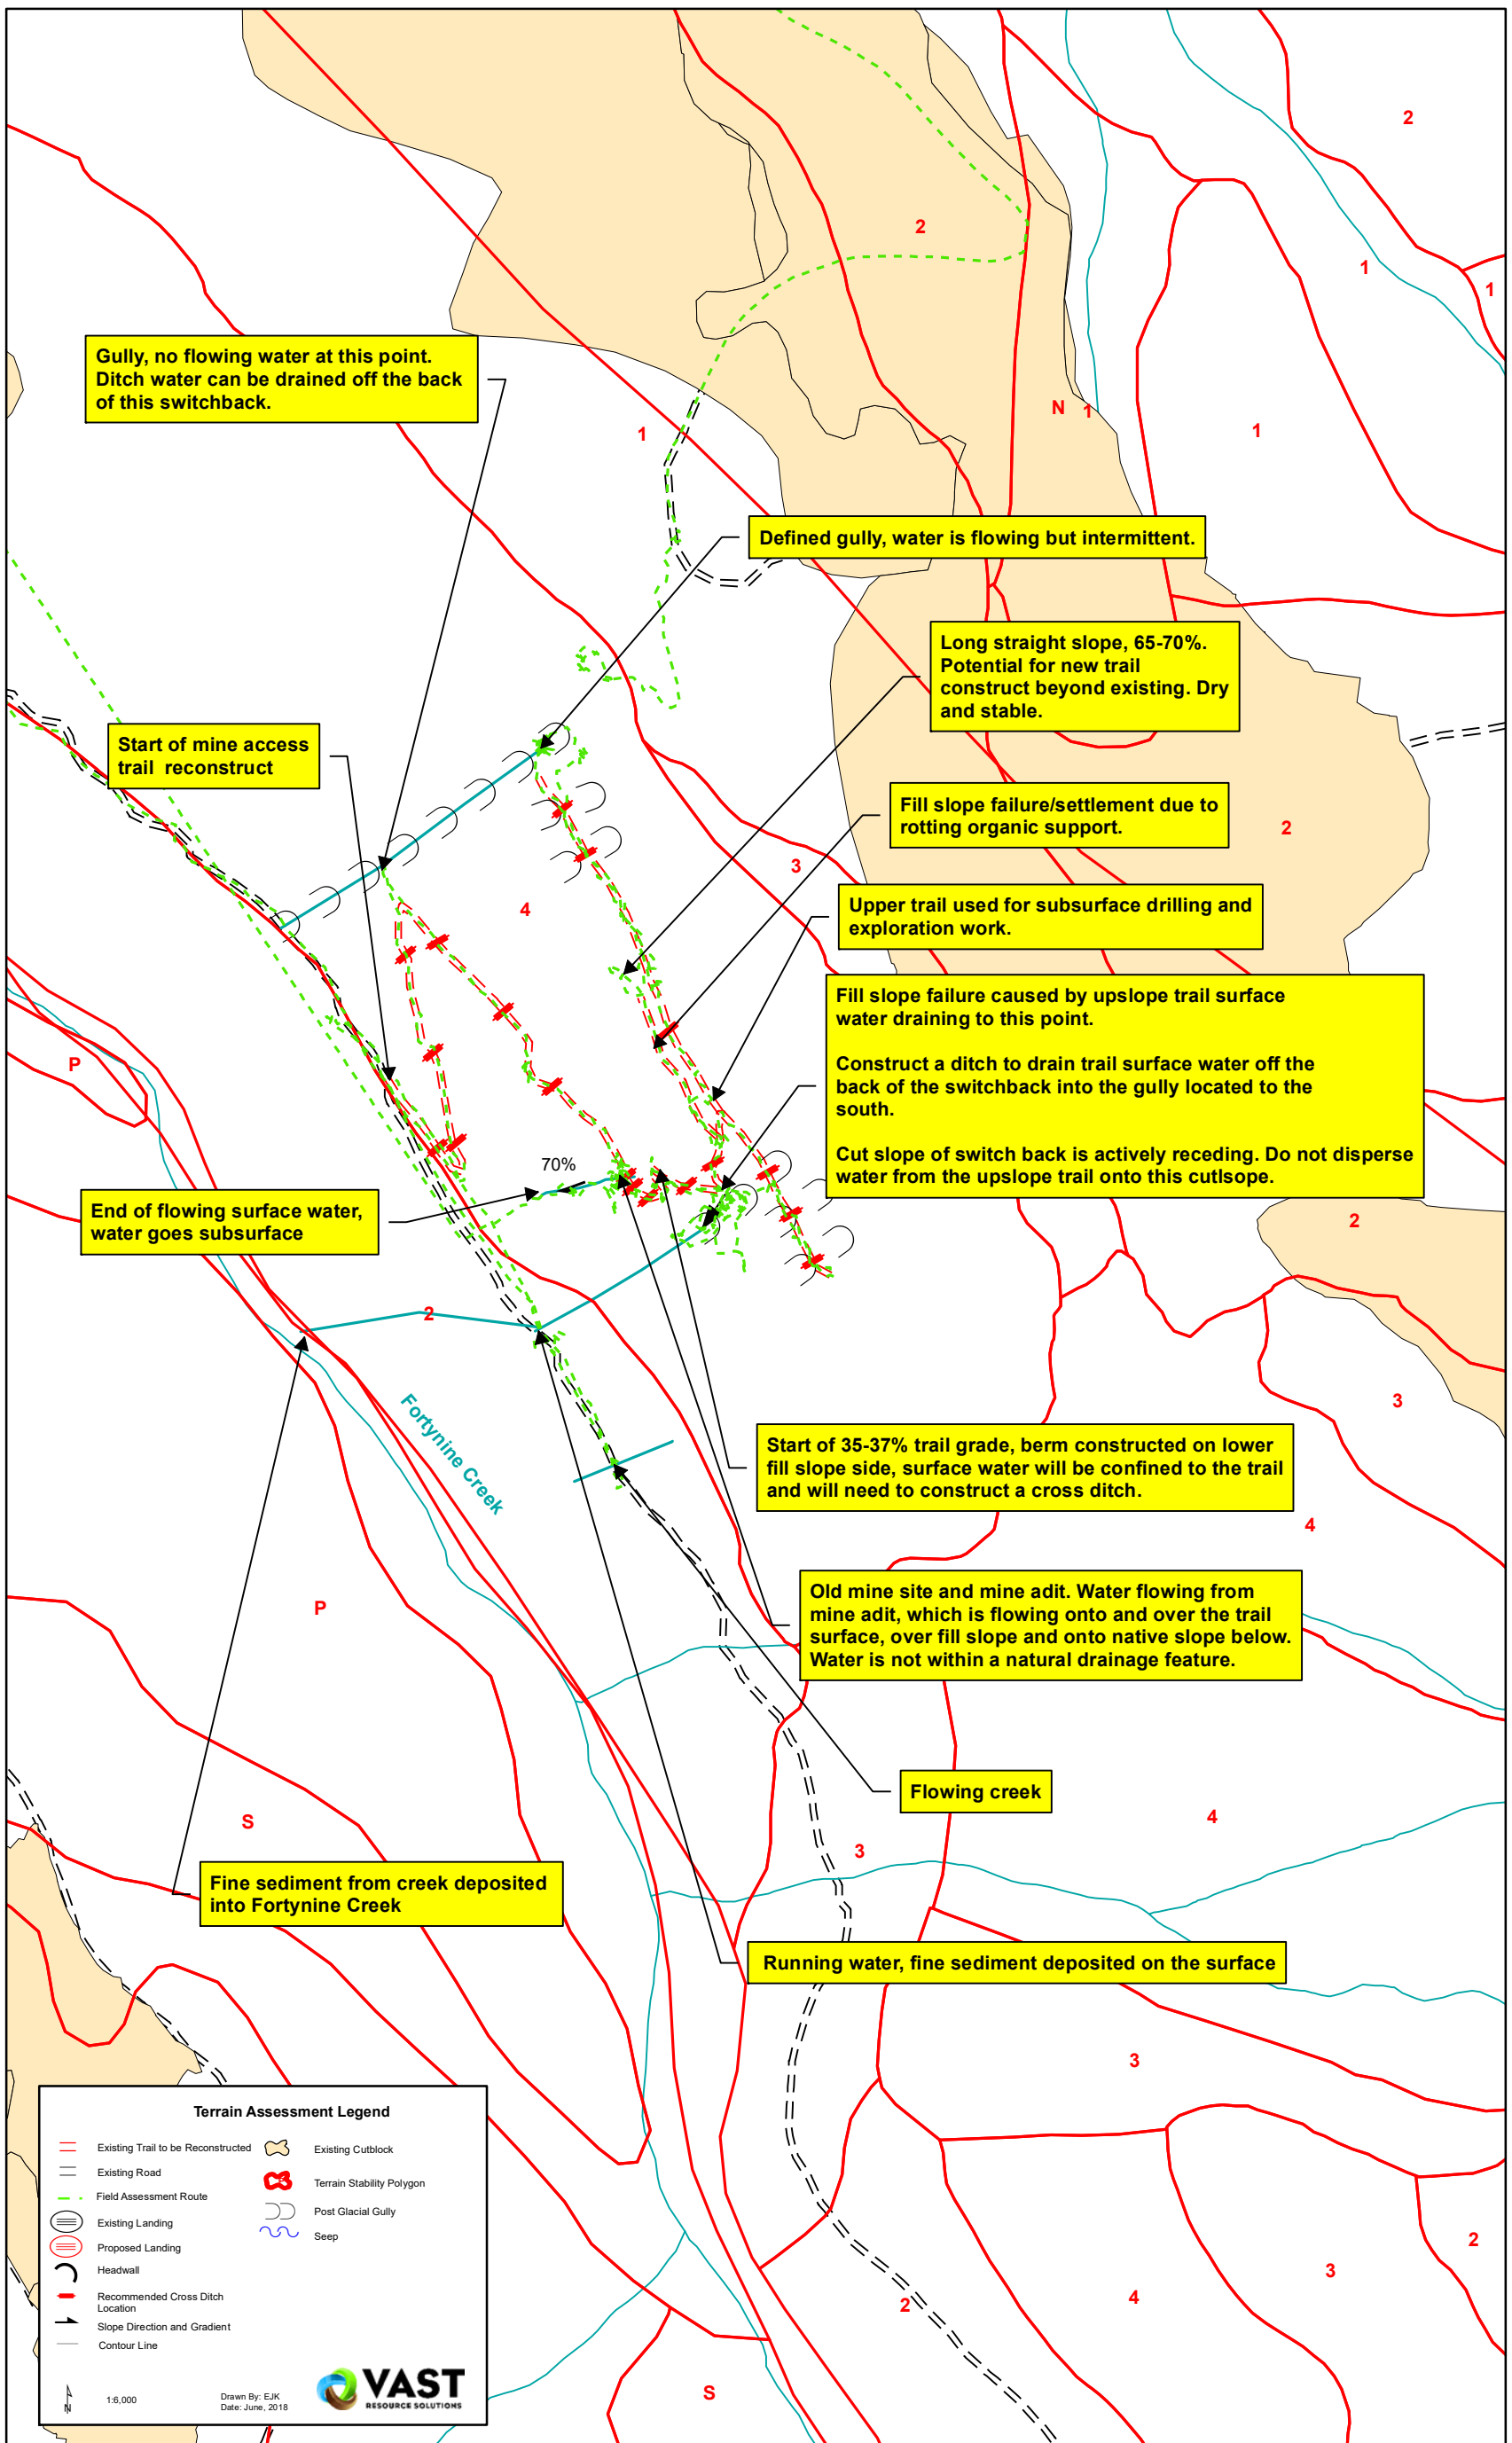
Figure 2: Site Assessment Map

Significant water was observed to be flowing from an adit located on the cut slope side of the existing trail (Figure 2). It is our understanding that this this adit was constructed approximately 100 years ago. The water flowed out of the adit onto and over the trail surface. The majority of the water was contained to one location where it crossed the trail and dispersed to the slope below. This water was not contained within a defined channel. The water flowed overland on 65-70% slope, spreading wider with decreasing elevation, until it disappeared subsurface approximately 75 m below the trail. Slope instability is not expected to occur if this water is maintained in the historic path and additional inputs of water do not occur. If this water is to be moved to a new location, it is to be completed under the direction of a Qualified Professional (QP).

A recent (<5 years old) landslide exists within the fill slope of the trail (Figure 2). The estimated cause of this debris slide was up grade trail surface water directed to this location. This fill slope is unstable and will require some minor slope reworking.

The slide is approximately 5-8 m wide, 10-15 m long and 1 m plus deep. The failed soil material is comprised of a localized blanket deposit of Silty Clay to Clayey Silt colluvium, which deposited into the gully and creek below. Flowing water emerged from the failed material at the lower elevations of the deposition zone and continued to flow downstream carrying sediment rich water. Fine sediment has been deposited along the entire length of the creek and turbid water has reached Fortynine Creek, located more than 300 m downslope.

The slide is located directly below a switchback where significant material was removed from the cut slope and deposited to the lower fill slope side. Organics and old mining material (ie. metal rail tracks) exist within the failed material zone. The cutslope above the switch back is receding up the slope and must not be disturbed.

Overall, the existing fill slope failure headwall will continue to be active until trail surface water is redirected away from the headwall towards the gully located to the south and the oversteepened headwall within the fill slope is reworked to reduce the slope. It is expected that sediment rich water will continue to flow within the stream and be deposited downslope and into Fortynine Creek for an undetermined length of time into the future, or until the failed material becomes stable and significant vegetation is established.

- Pull back the oversteepened headwall located within the fill slope to minimize addition material from failing;

- Construct a ditch to collect trail surface water from upgrade and direct away from the failed fill slope towards native soil within the gully located off the back of the switchback to the south. Water must not be directed to fill slope material. Construct a sediment catch basin prior to the gully. A ribbon is hung in the approximate location to disperse the ditch water into the gully;
- Monitor for additional signs of slope instability at this location and contact a QP if instability is observed;
- A site visit is to be completed by a QP within two weeks after reconstruction to assess the slope stability hazard; and
- Do not disperse water from the upper existing trail towards the receding switchback cutslope located directly above the fill slope failure (Figure 2).

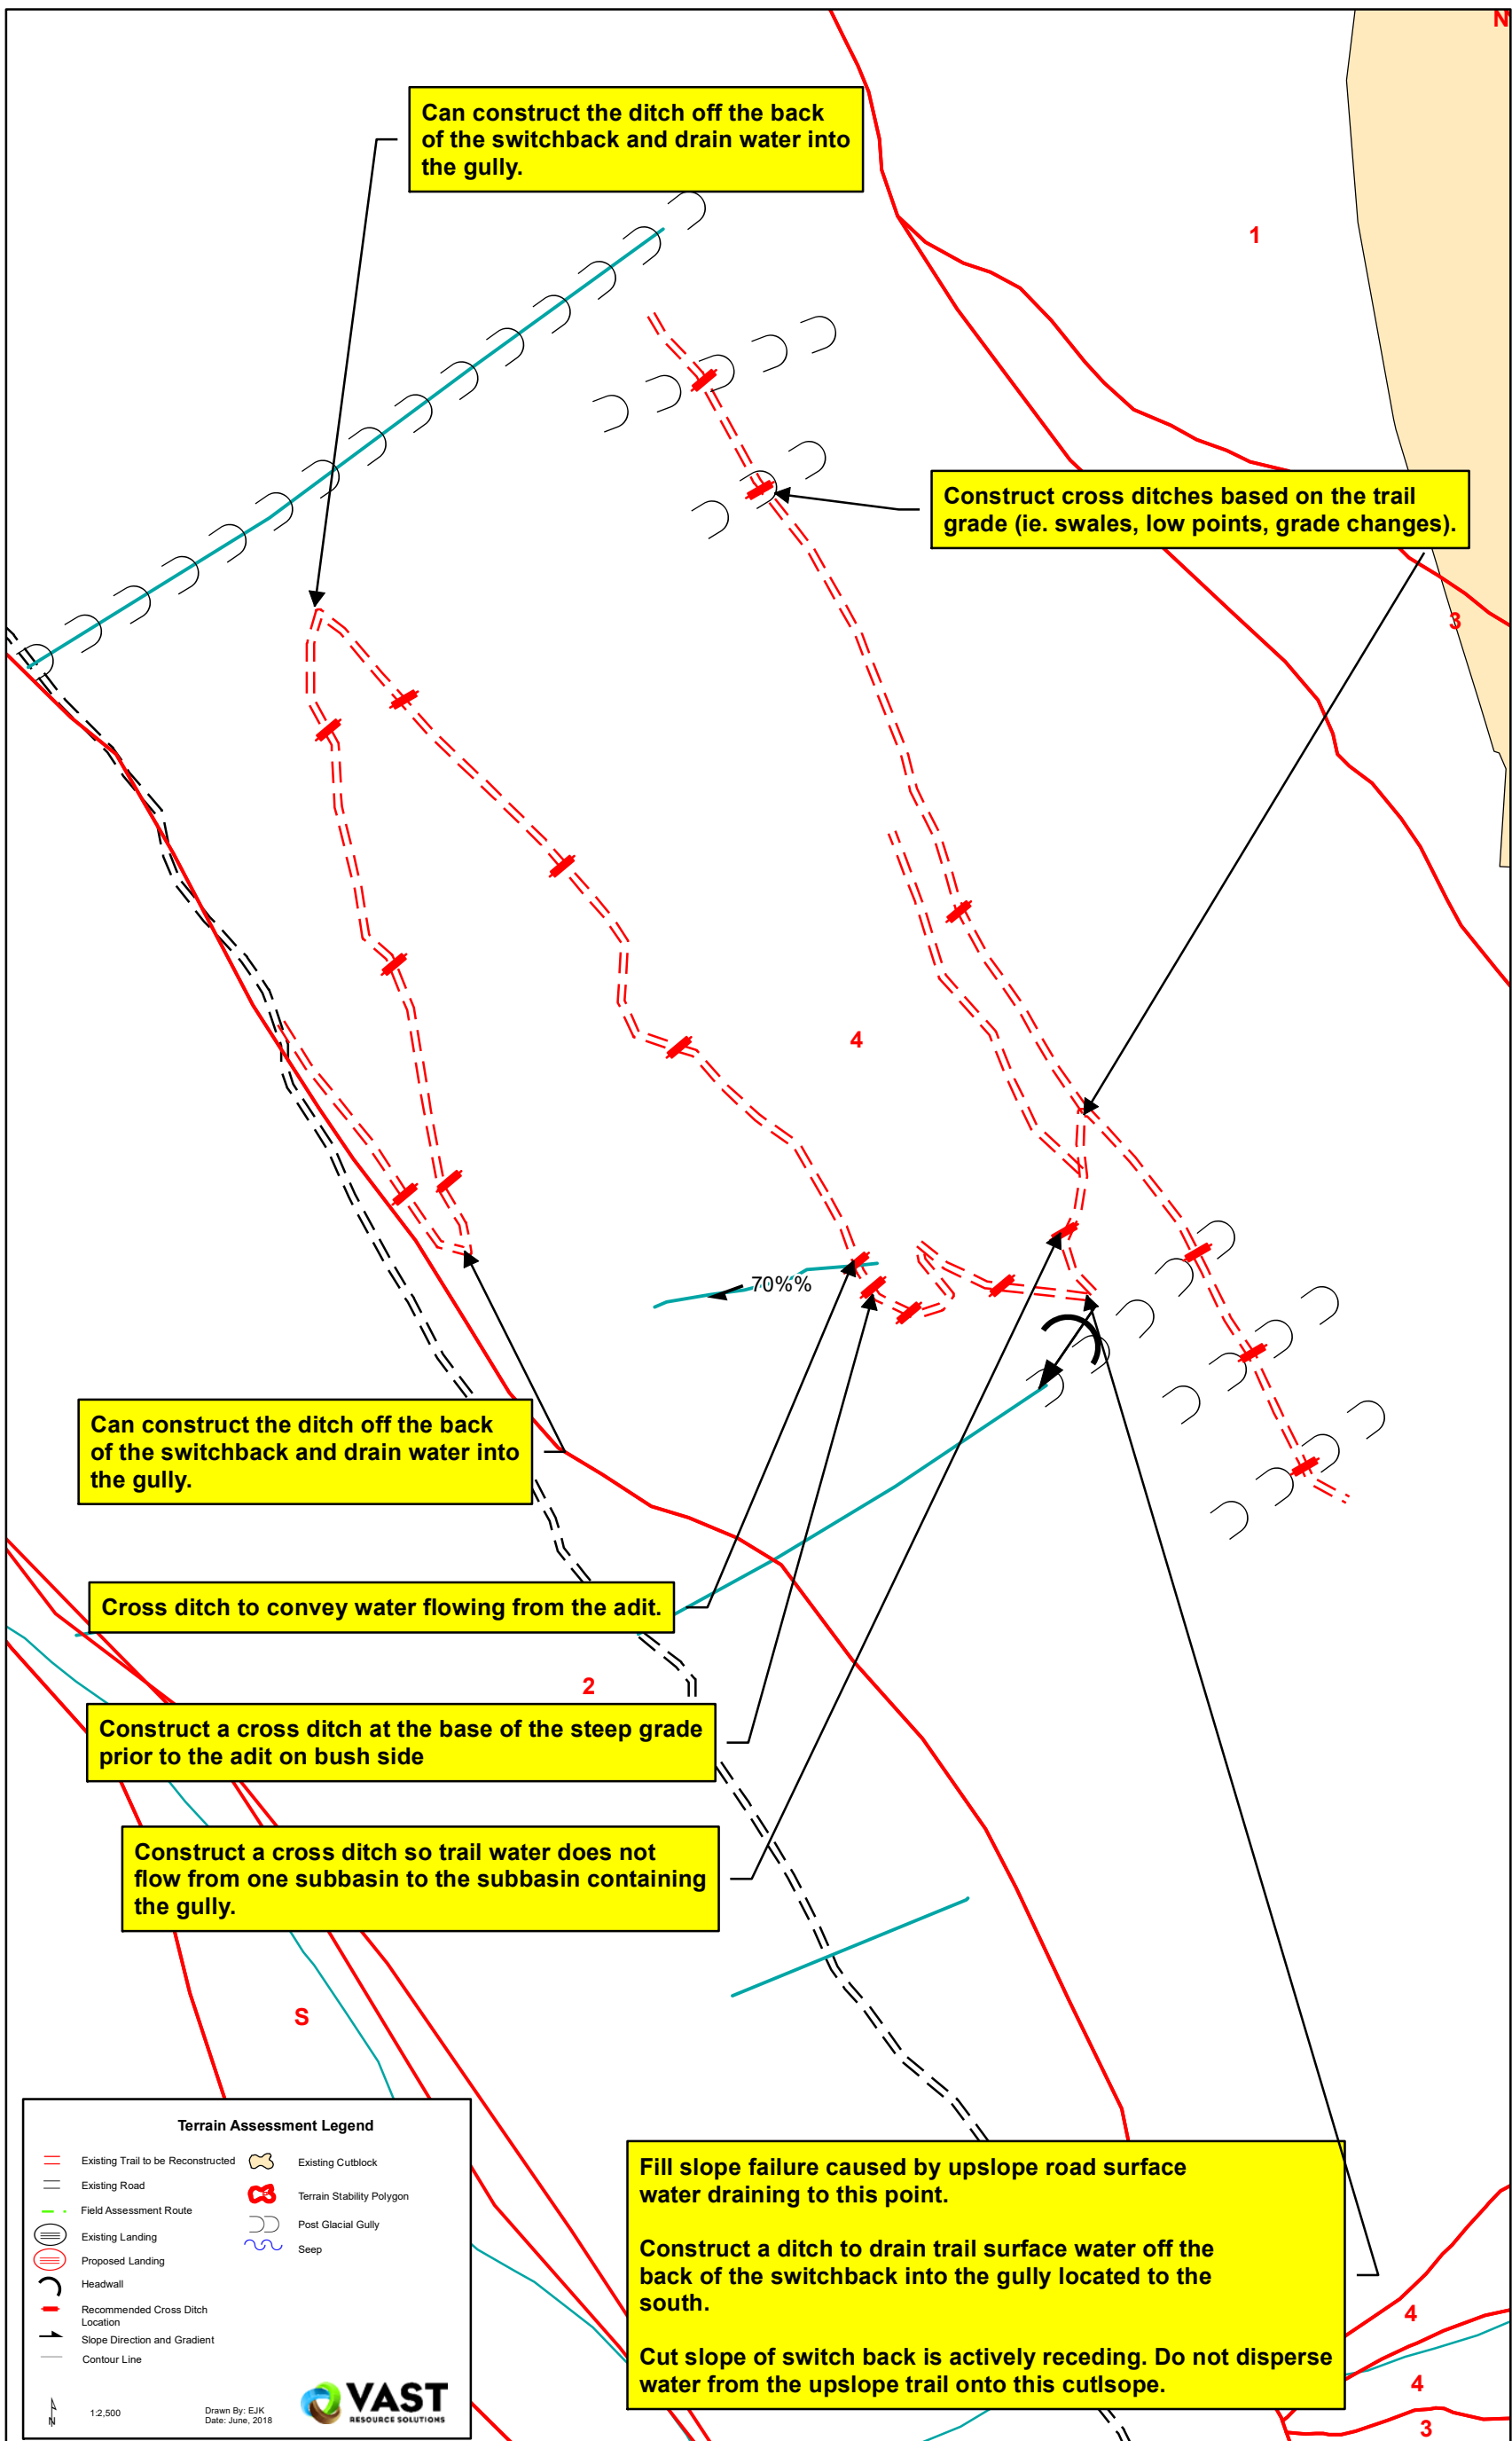
Figure 3: Recommended Cross Ditch Locations Map

No additional water was observed to be running on the trail surface at the time of the assessment, but it is expected during the spring freshet or during periods of heavy rain events. Cross drain structures such as cross ditches will be required to maintain the natural drainage pattern.

Recommended cross ditch locations are provided based on the field assessment and illustrated in Figure 2.
